Gold Ray Dam Project

Rehabilitation Technical Memo

February 2010

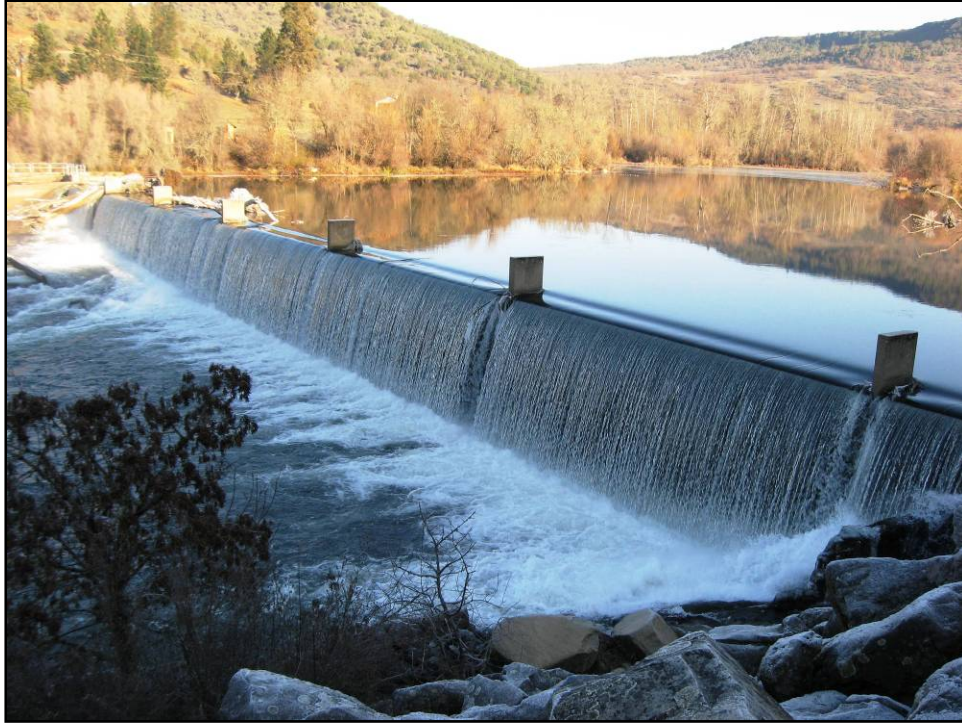
Figure 5: Gold Ray Dam from South Abutment, December 8, 2009

The Gold Ray Dam is a 1941 slab and buttress design (often referred to as an “Ambursen” dam) consisting of an inclined upstream slab spanning simply supported between downstream buttresses. The dam is 480 feet long with an overflow section of 370 feet. The elevation of the crest of the dam is 1146.0 feet. The maximum height of the dam is 40 feet. At Gold Ray Dam the upstream slab varies in thickness from 14 inches at the crest to 25 inches at the bottom of the tallest sections. The bottom of the slab is noted on the drawings to be keyed into “firm rock” a minimum of 2 feet. The buttresses, which are spaced at 15 feet on center, vary in thickness from 21 at the deepest sections to 15 inches near the top. The left and right abutments consist of a thickened buttresses acting as a seat-type (bridge) abutment for the upstream slab.

In general, the dam and appurtenant structures appear to be in remarkably good condition given their age, environment, and apparent minimal maintenance and upkeep. That said, the majority of dam and water control structures on the site are in a severe state of deterioration. With the exception of the fish ladder, which appears to still be functioning to some extent, the entire facility is functionally obsolete and appears unsafe from both a dam safety and public safety perspective. There is evidence of significant concrete deterioration, cracking and displacement throughout the site. Of primary concern, however, is the fact that no routine inspections or observations can be made of the interior portions of the slabs and buttresses.

Prior to the design of the remediation measures for the existing dam and appurtenant structures a comprehensive structural inspection will be required. The inspection will focus primarily on the existing slab and buttress dam, and specifically on the condition of the interior portions of the dam. Temporary access will need to be obtained into the interior of the dam by diverting the flow over the dam at several locations and providing safe boat access to the then exposed interior. The condition of the bottom of the slab, the buttresses, and the struts can then be ascertained.

Prior to the design of the remediation measures for the existing dam and appurtenant structures a comprehensive geotechnical investigation will be required. A geotechnical field investigation will be performed to characterize subsurface conditions at the site. Samples of subsurface soil and rock will be collected in test pits and borings and laboratory tests will be performed to determine physical engineering properties. The field investigation will consist of approximately 10 borings; five along the centerline of the dam, one each at the left and right abutments, and three conducted along the training walls and forebay walls. Boring depths will vary from 75 to 150 feet. Test pits could also be required at the left and right abutments. A geotechnical report would then be developed including the investigation results, analysis and design parameters. The report will also include an updated seismicity.

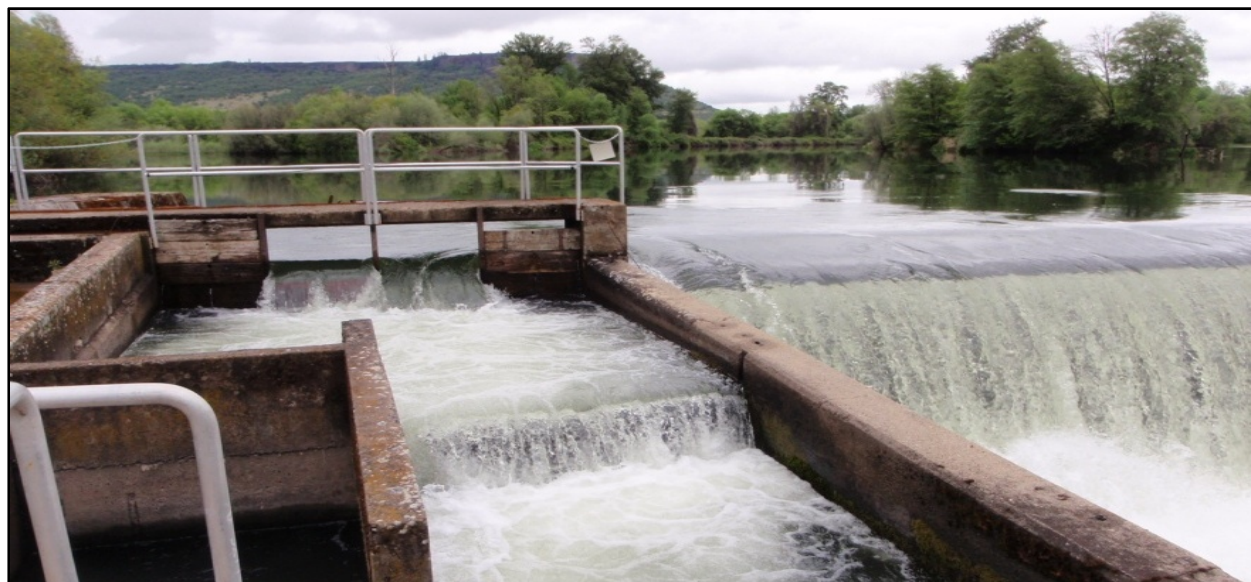
Figure 10: Looking Upstream at Fish Ladder Flow Control Structure with 3,800 cfs Total Flow in the River

The existing dam is a run-of-the-river type structure that does not have mechanisms to control flows. The existing concrete dam acts as a weir with flow going over the dam similar to a broad crested weir. In addition, water flows down the fish ladder and the powerhouse raceway. Figure 10 shows the existing upstream entrance to the fish ladder in relationship to the dam structure.

ODFW uses an energy dissipation factor (EDF) as a surrogate for velocity criteria in fishways in accordance with Oregon Administrative Rules (OAR) 635-412-0035. Based on the existing conditions it is evident that the current fish ladder does not meet these criteria for all flow levels. In addition, step heights between weirs exceed 1.25 ft which is outside current criterion for fish passage.
