# Jackson County Gold Ray Sediment Assessment Report

**October 2009**

**HDR**

**Preliminary Report of the Sediment Study Conducted at Gold Ray Reservoir,  
Jackson County, Oregon**

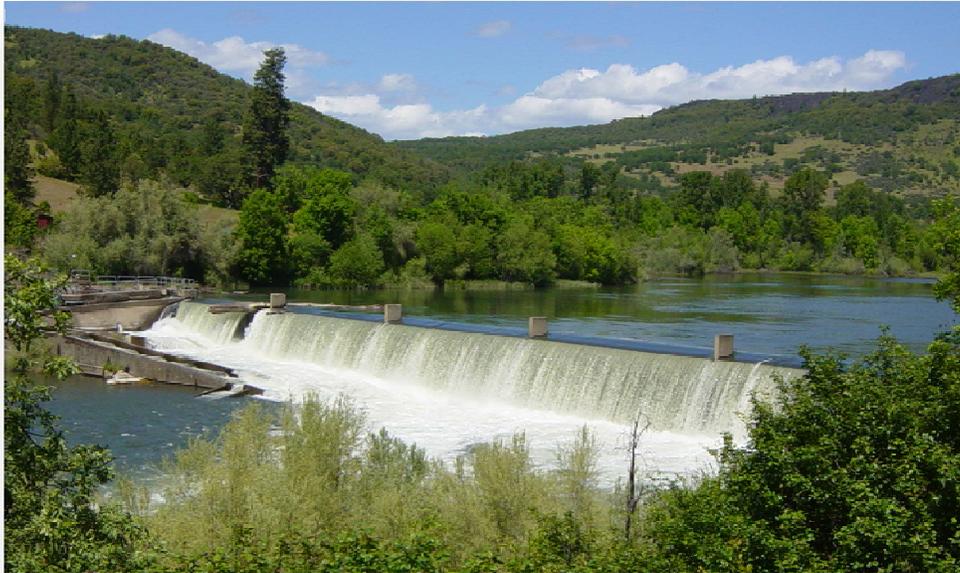
Figure 1. Gold Ray Dam from downstream left bank.  
Photograph ca. 2008. Source: Bill Elliott

Gold Ray Dam (Figure 1) is located in Jackson County, Oregon on the Rogue River at River Mile 125.7. The original dam was a log crib structure built in 1904 by Condor Water and Power Company for the purpose of generating power by rope-driven turbines. The operation was acquired in 1921 by California-Oregon Power Company, frequently referred to as COPCO, which in 1941 constructed a straight-crest, concrete gravity dam immediately downstream of the original log crib dam. The concrete structure is 360 feet across and 38 feet high (approximately 35 feet is exposed above the sediment on the downstream side). The log crib dam was inundated after the construction of the concrete dam, and is still intact. On the right side of the dam is a rock and mortar wall that forms the raceway that diverted flows through the powerhouse and turbines. The powerhouse is no longer in use; power generation ceased in 1972. Flows from the powerhouse used to return to the river through an outlet channel blasted out of the bedrock when the original dam was built in 1904. There is a fish ladder structure with two long “arms” adjacent to the raceway wall; one arm of the ladder is approximately 160 feet long and is adjacent to the raceway wall while the second is perpendicular to the raceway and extends approximately 120 feet into the river channel.

Immediately upstream of the concrete dam is the original log crib dam built in 1904. This older dam has a height approximately 5 feet lower than the concrete dam. The log dam arches upstream from either end and is connected to the concrete at the left and right extents of both dams. The widest space between the two dams is approximately 25 feet. An historic photo of the log crib dam is shown in Figure 2.

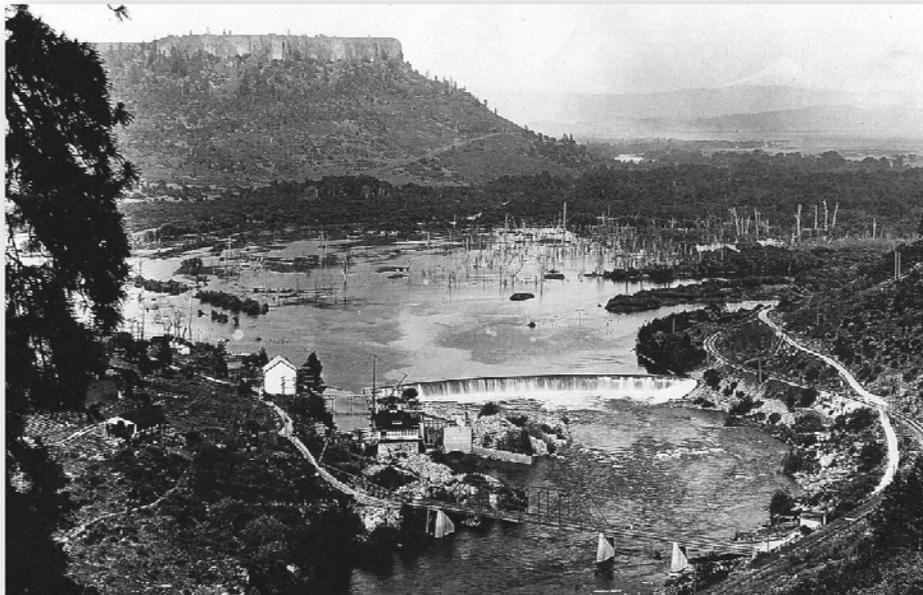
Figure 2. Inundated area that resulted after the completion and filling  
of the impoundment from the construction of the log crib dam.  
Photograph ca. ~1936. Source: Southern Oregon Historical Society

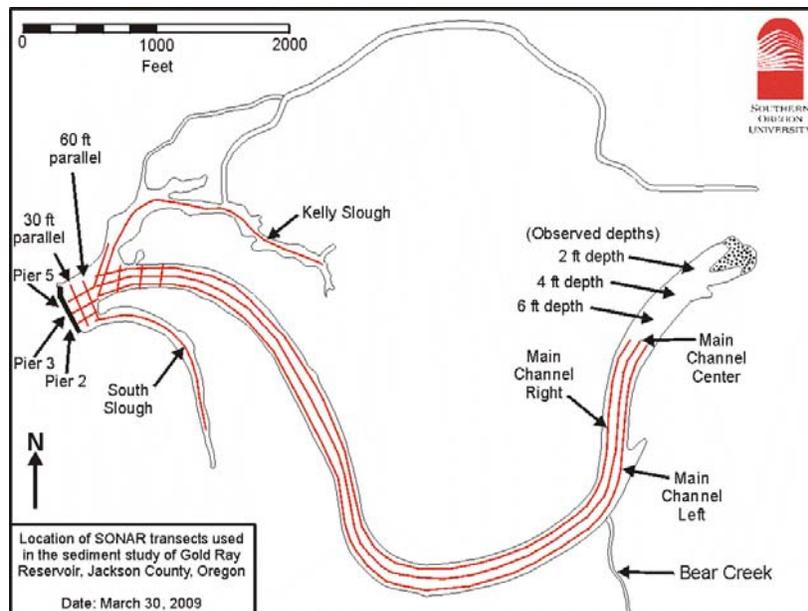
**Figure 2.** Location of longitudinal and cross-sectional transects used to collect SONAR data in the Gold Ray Reservoir

Three longitudinal and three cross-sectional transects were completed on the main channel of the Rogue River extending from approximately 200 ft above the dam to approximately 800 ft upstream of the confluence with Bear Creek. Two cross-sectional transects were pulled at 30 and 60 ft parallel to the dam. Finally, the tow fish was rigged to buoys and floated to within 5 ft of the dam, and then pulled upstream to provide transects perpendicular to the dam at Pier 2, Pier 3, & Pier 5. Refer to Figure 2 for the location of these transects.

Longitudinal transects were also conducted for Kelly Slough (River Right) and South Slough by pulling the tow fish 3 ft below the water line. The shallow tow was needed to avoid interference from river weed. In addition, the sloughs were much shallower, which necessitated the use of a smaller boat and a shallower placement of the tow fish. Again, refer to Figure 2.

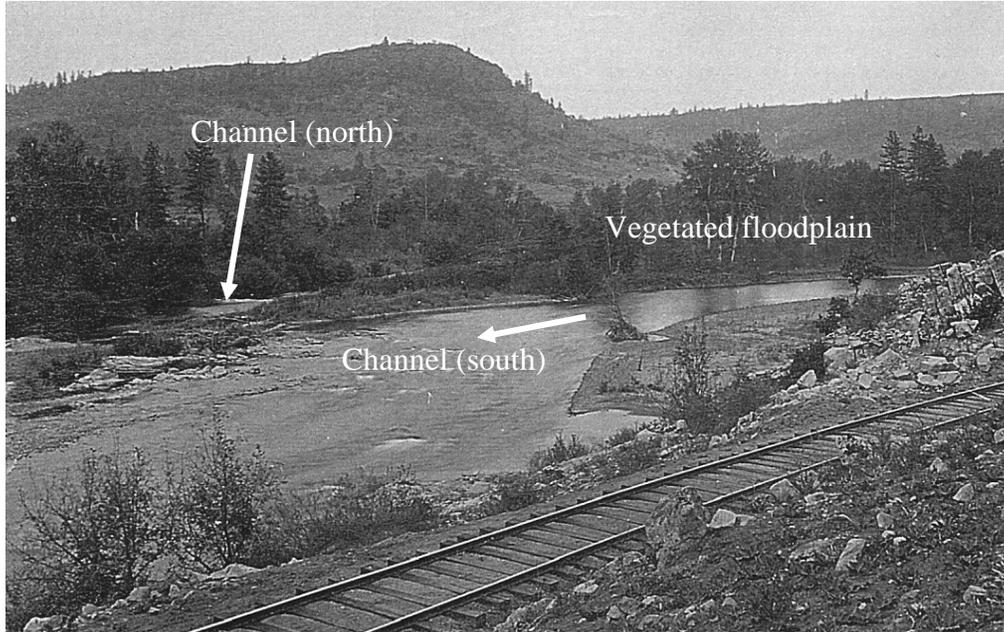
**Figure 3.** Historic photograph at the approximate location of the log crib dam prior to its construction. Please note the presence of a channel to the north of the vegetated floodplain between the two channels of the Rogue River.

First, historic photographs show that prior to the construction of Gold Ray Dam, water was flowing in a channel to the north of the vegetated floodplain (Fig. 3). The Rogue River may have been in the process of switching to this northern channel prior to the construction of the log crib dam. In addition, the older channel (present-day main channel of the Rogue River) probably

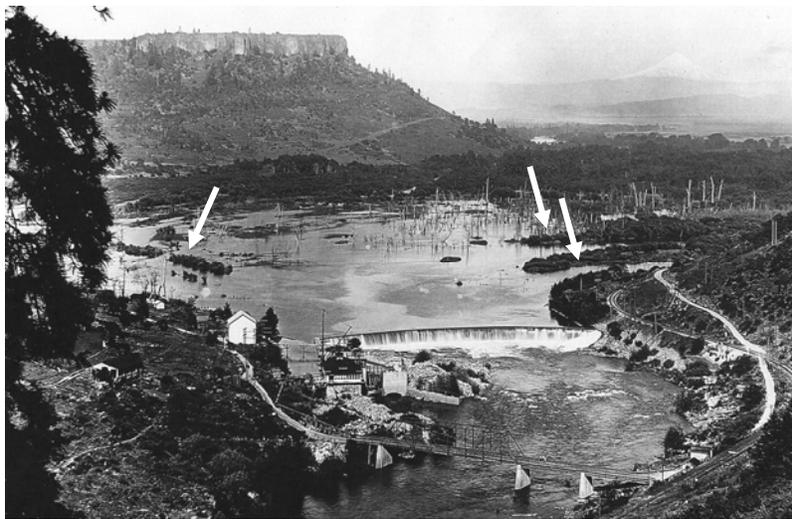
**Figure 4.** Inundated area that resulted after the completion and filling of the reservoir from the construction of the log crib dam. Arrows are highlighting natural levees along pre-existing channels. Circa 1936.

formed natural levees composed of overbank sediments during flood events. With the construction of the log crib dam, the floodplain between these two channels became inundated (Fig. 4) with the exception of the elevated natural levees along the pre-existing channels. The

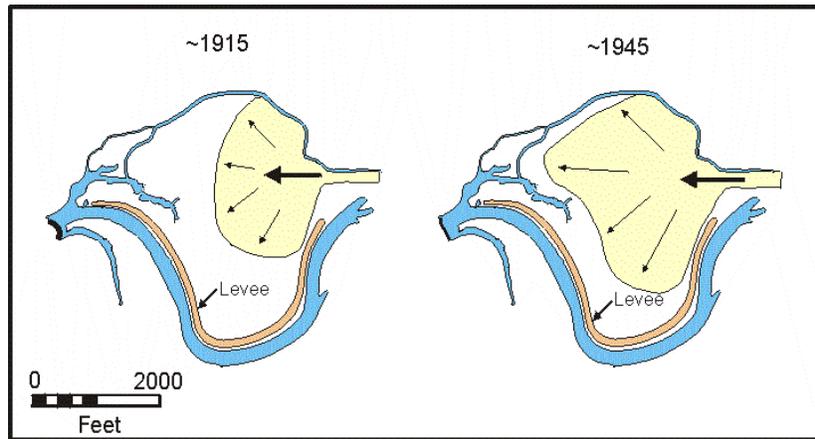
**Figure 5.** Depositional model for the deposition of sediment in the floodplain that sits between the north and south channels of the Rogue River in Gold Ray Reservoir.

Rogue River continued to follow this newly avulsed channel and created a delta that filled in the low lying areas of the floodplain between the two channels (Fig. 5). This area would have been further inundated after the construction of the concrete dam in 1941, providing additional space for sediments to accumulate. This hypothesis is further supported by the presence of distributary channels and sand bars observed on the August 1952 aerial photograph of this part of the reservoir. Using the additional surface area of the Gold Ray Reservoir present in August 1952,

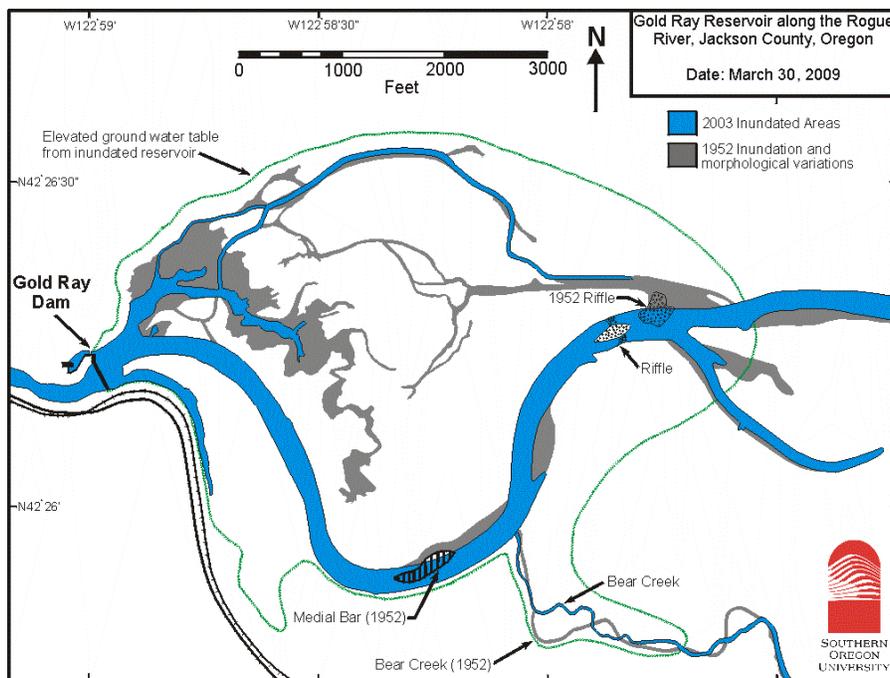
**Figure 6.** Comparison of the morphology of Bear Creek, the Rogue River, and Gold Ray Reservoir using 1952 versus 2003 aerial photographs. Note the increased surface area of Gold Ray Reservoir in 1952. Also note the presence of distributary channels that bifurcate from east to west.

this would account for an additional 160,000 cubic yards of sediment assuming a thickness of 3 ft of sediment (Fig. 6). Extrapolating for this entire area, the amount of sediment deposited may be close to ~900,000 cubic yards, again assuming 3 ft of sediment. If 6 feet of sediment were

deposited, then the accumulation could be on the order of 1,800,000 cubic yards. Finally, if the Gold Ray Dam were removed, the sediment deposited in this area most likely would not be mobilized, and would result in an elevated terrace along the Rogue River.

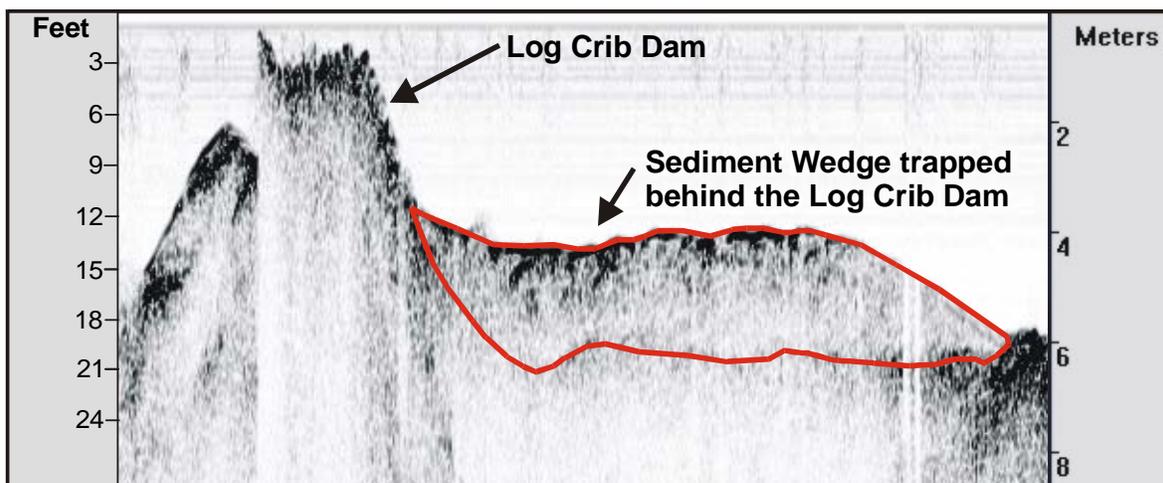
**Figure 7.** SONAR Profile along the Pier 5 transect perpendicular from the concrete dam upstream showing the submerged log crib dam. The present concrete dam is just to the left of this SONAR profile. Note the sediment wedge that is impounded by the log crib dam and the rapid increase of water depth downstream of the log crib dam. The thickness of deposited sediment between the submerged log crib dam and the concrete dam is minimal on river right and center.

Another unexpected result of this study was the discovery that most, if not all, of the original log crib dam constructed in 1904 remains intact just above the concrete dam erected in 1941. This can be seen in the SONAR profiles that were collected perpendicular to the dam (Fig. 7) and on the February 2003 aerial photograph (Fig. 8). The presence of the submerged log crib dam is a significant historic and scientific discovery and would need to be addressed in a plan that proposes removal of Gold Ray Dam.

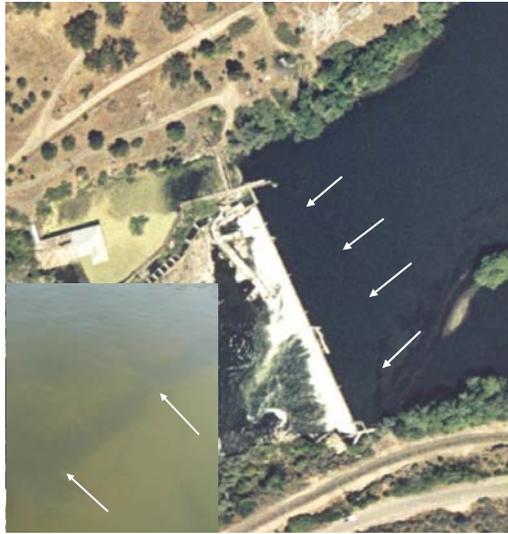
**Figure 8.** Aerial photograph with an inset photograph showing the location and presence of the 1904 log crib dam.

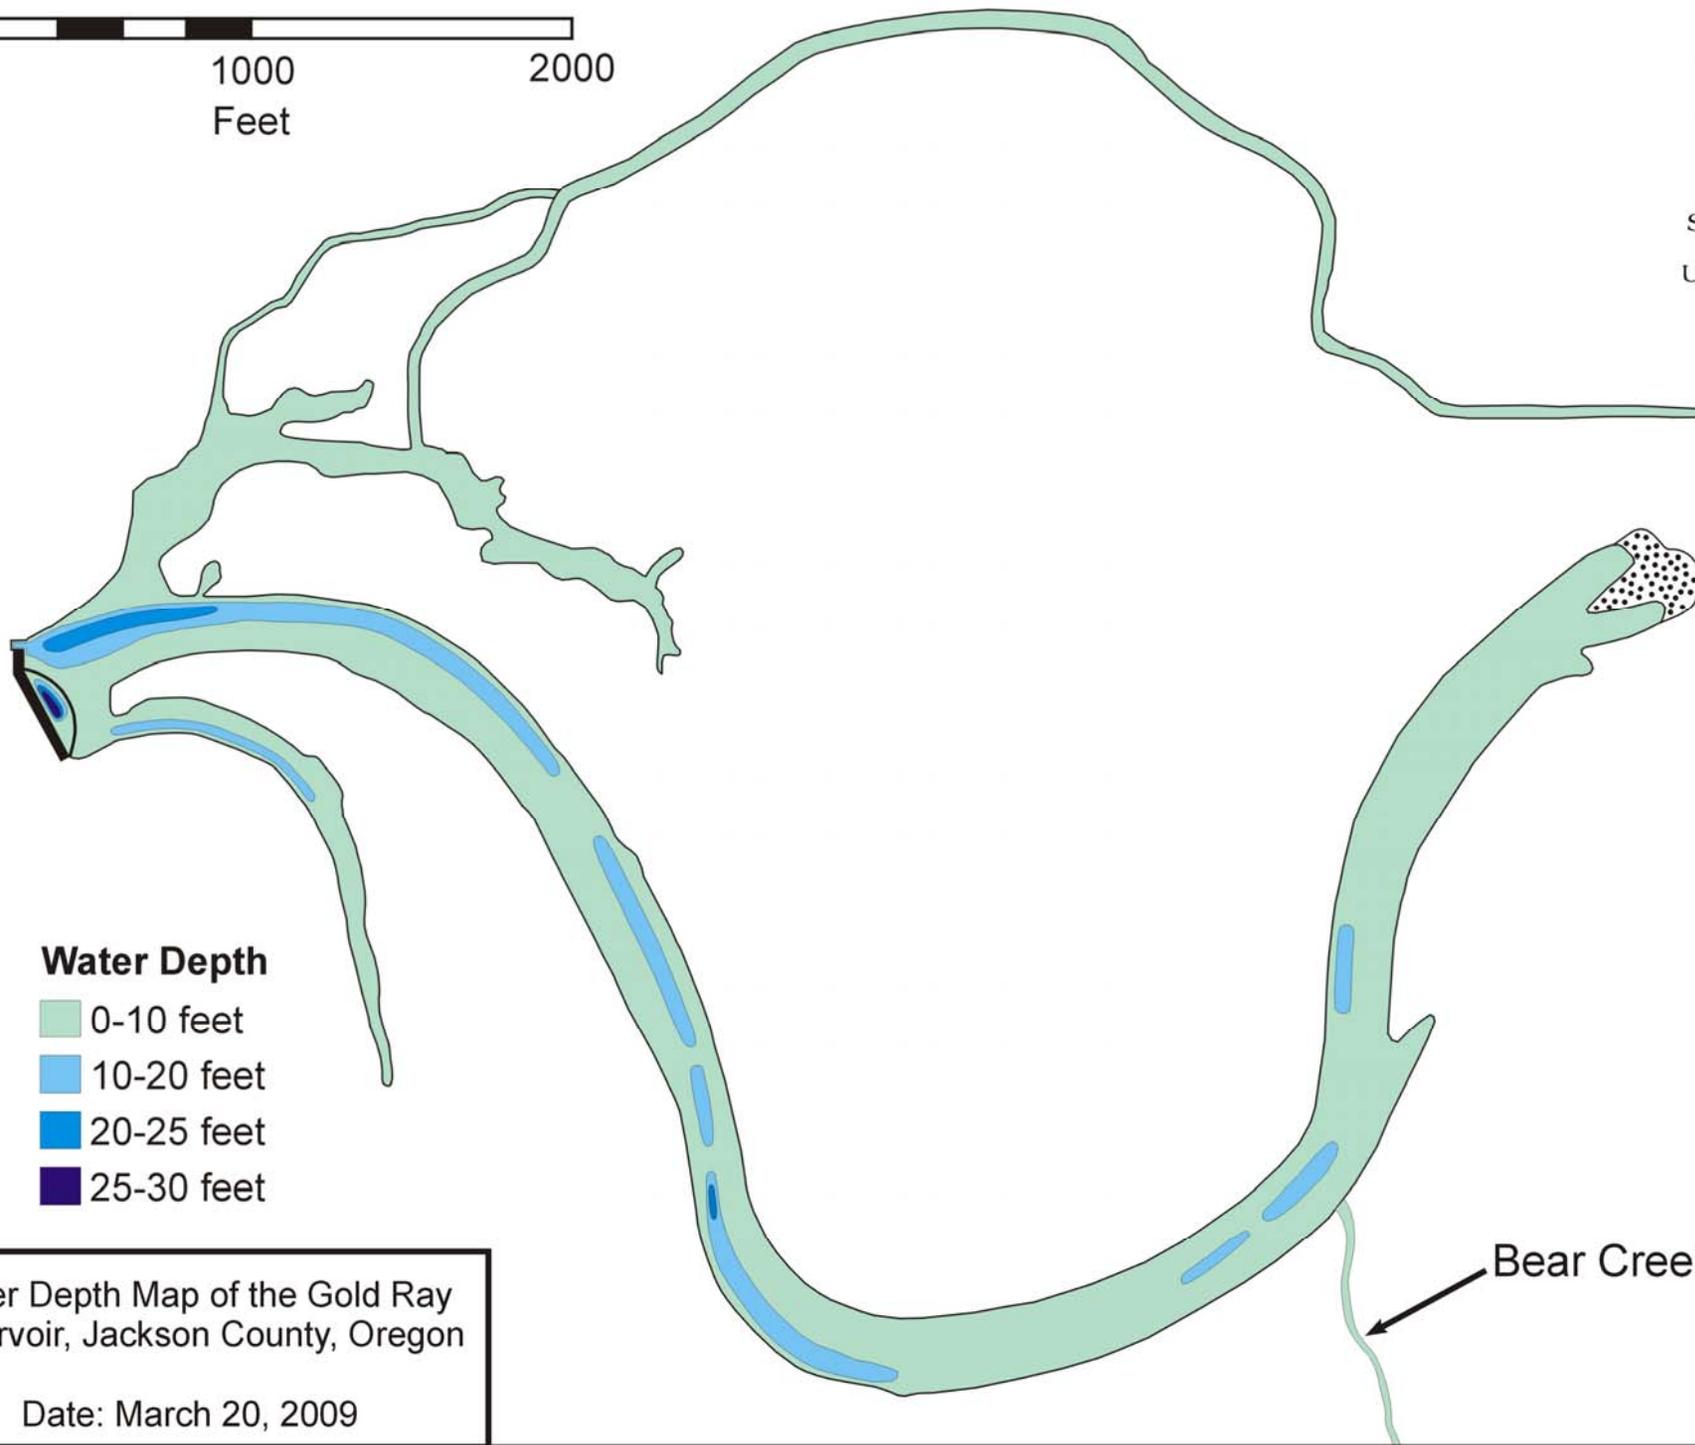
Water Depth Map of the Gold Ray Reservoir, Jackson County, Oregon

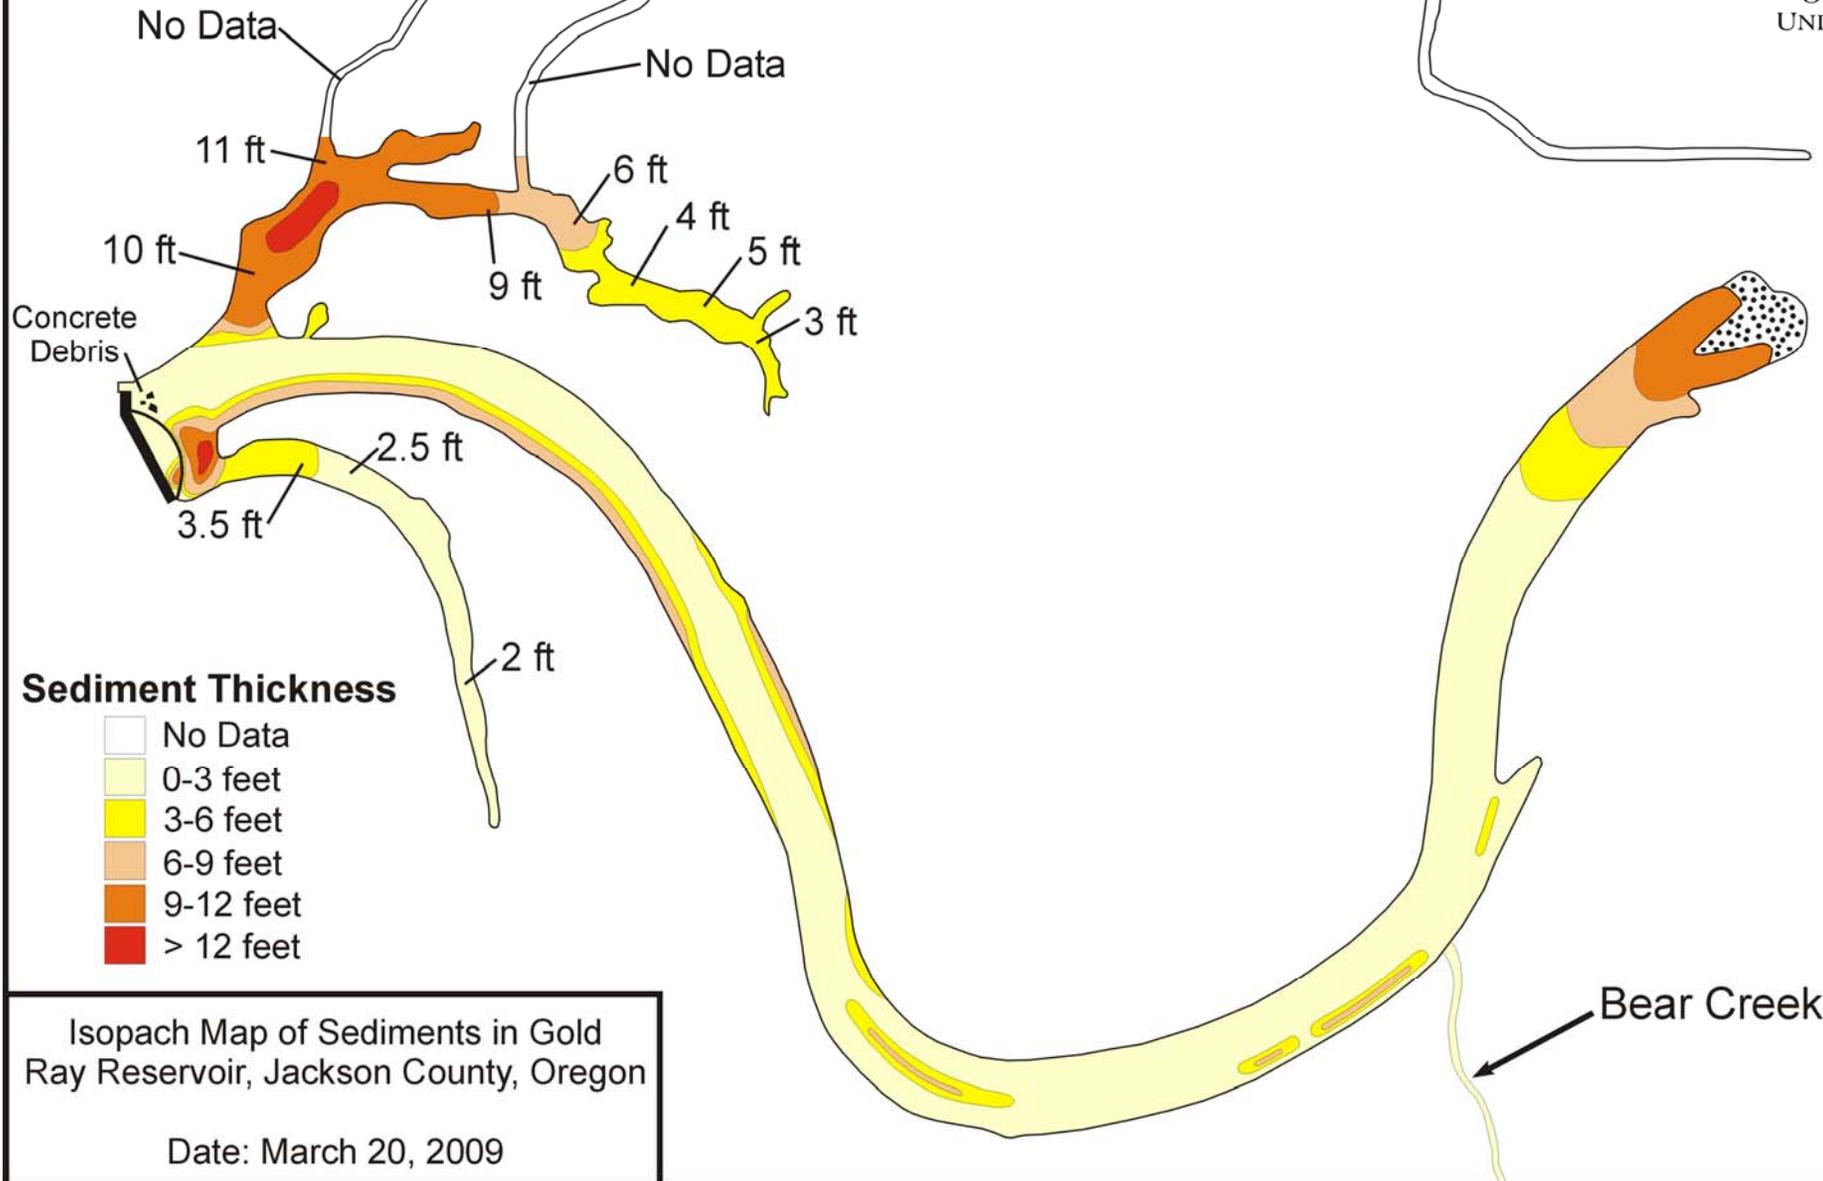
Isopach Map of Sediments in Gold Ray Reservoir, Jackson County, Oregon

Eric Dittmer of SOU on March 31, 2009. The report included an isopach map of sediment thickness in the impoundment as Plate 2. The SOU SONAR study report and an addendum are attached as Appendix A.

If the refusal was due to the core reaching the previous bed surface, then the refusal depth is a very good reflection of sediment depth at that location. If the refusal was due to compacted sand, the true depth of sediment cannot be calculated. It is unknown which of the two conditions hold true for the depths of refusal in the Gold Ray Dam impoundment. However, professional judgment was used by the vibracoring team (Shawn Hinz and Steve Saugen of Gravity Consulting and SOU Geology professors Bill Elliott and Eric Dittmer) to infer the cause of the refusal (Dittmer and Elliott, 2009). The possible reason for refusal is listed in Table 3, with the maximum depth of refusal and the estimated depth of sediment provided in the isopach map (Plate 2 in Appendix A) at each of the 12 coring locations.

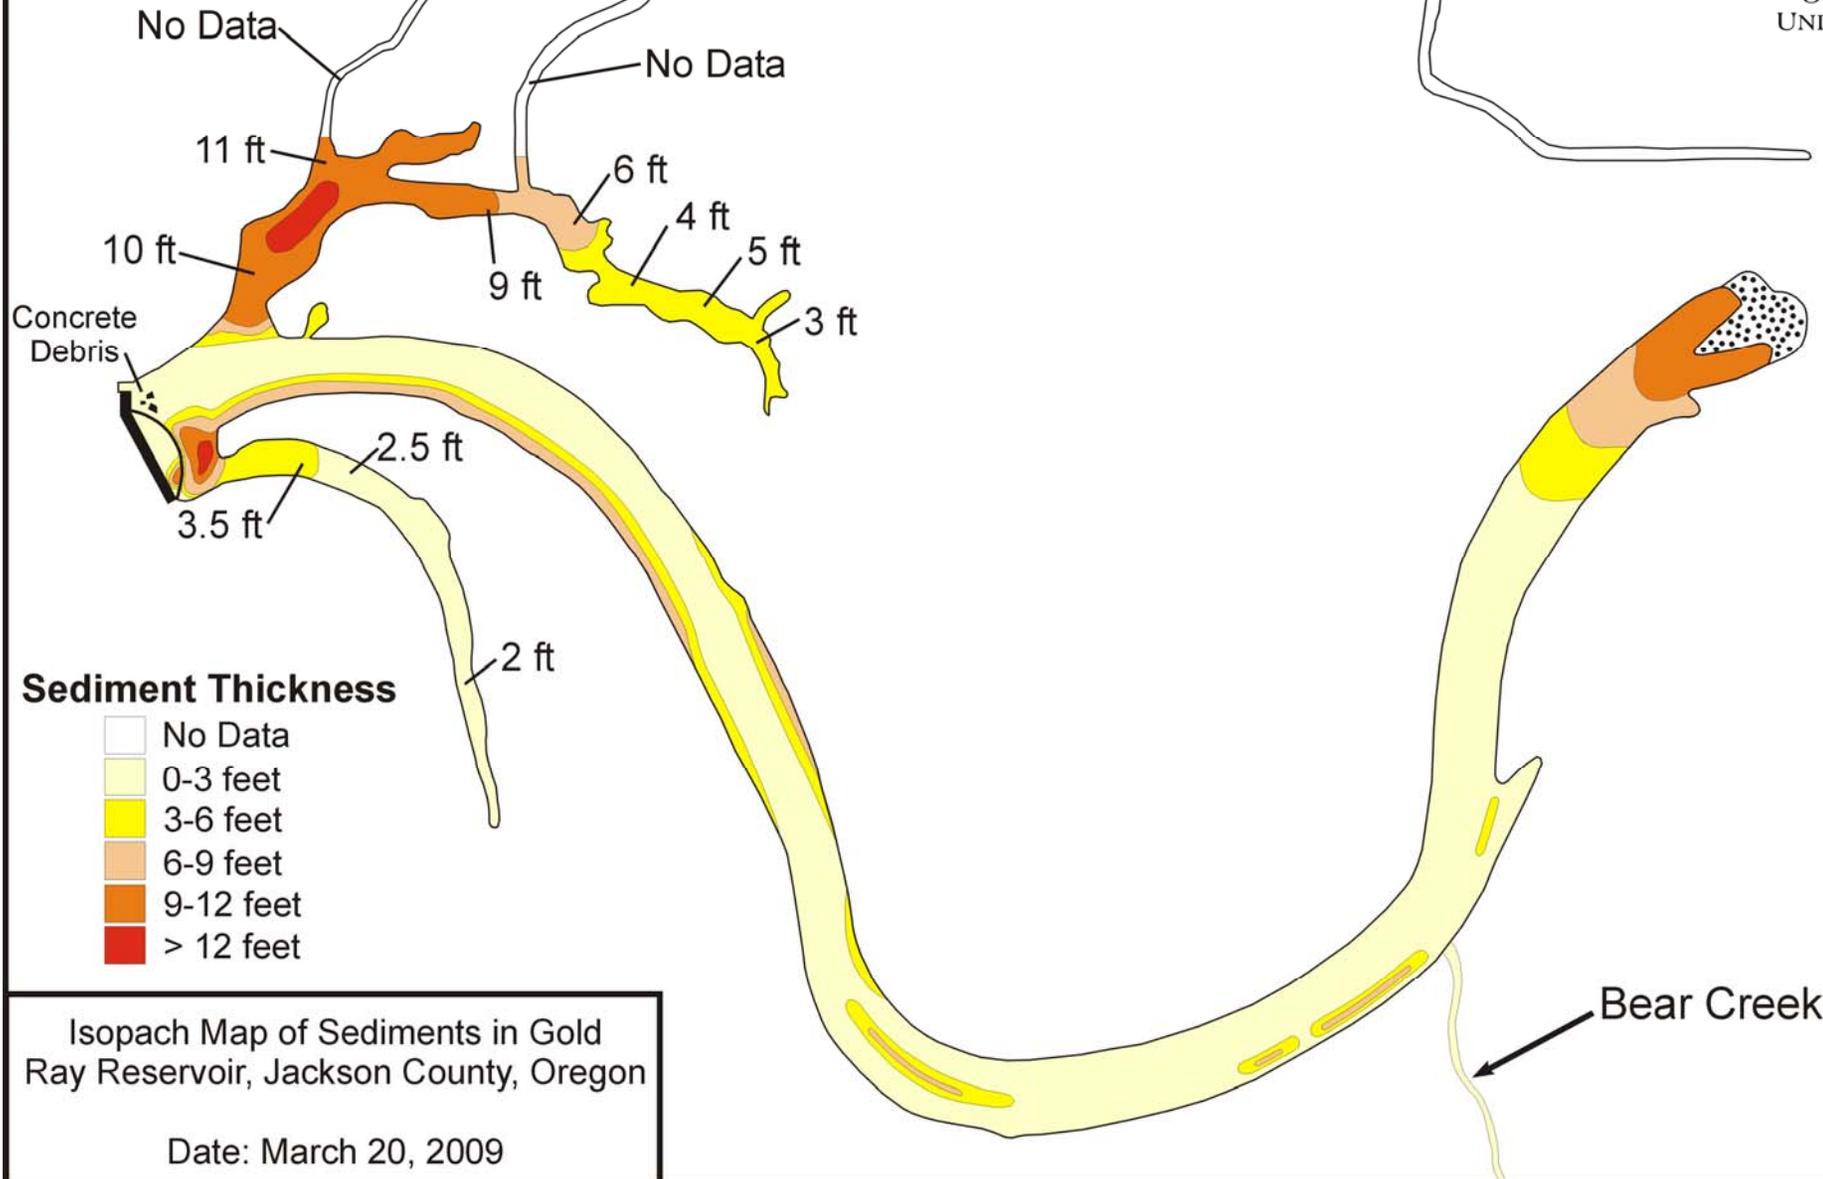
ATTACHMENT 1.  
ISOPACH MAP OF SEDIMENTS IN GOLD RAY RESERVOIR, JACKSON COUNTY, OREGON  
(ELLIOTT AND DITTMER, 2009)

Isopach Map of Sediments in Gold Ray Reservoir, Jackson County, Oregon

If the refusal was due to the core reaching the previous bed surface, then the refusal depth is a very good reflection of sediment depth at that location. If the refusal was due to compacted sand, the true depth of sediment cannot be calculated. It is unknown which of the two conditions hold true for the depths of refusal in the Gold Ray Dam impoundment. However, best professional judgment was used by the vibracoring team (Shawn Hinz and Steve Saugen of Gravity Consulting, and SOU Geology professors Bill Elliott and Eric Dittmer) to infer the cause of the refusal (Dittmer and Elliott, 2009). The possible reason for refusal is listed in Table 1, with the maximum depth of refusal and the estimated depth of sediment provided in the isopach map (Attachment 1) at each of the 12 coring locations.

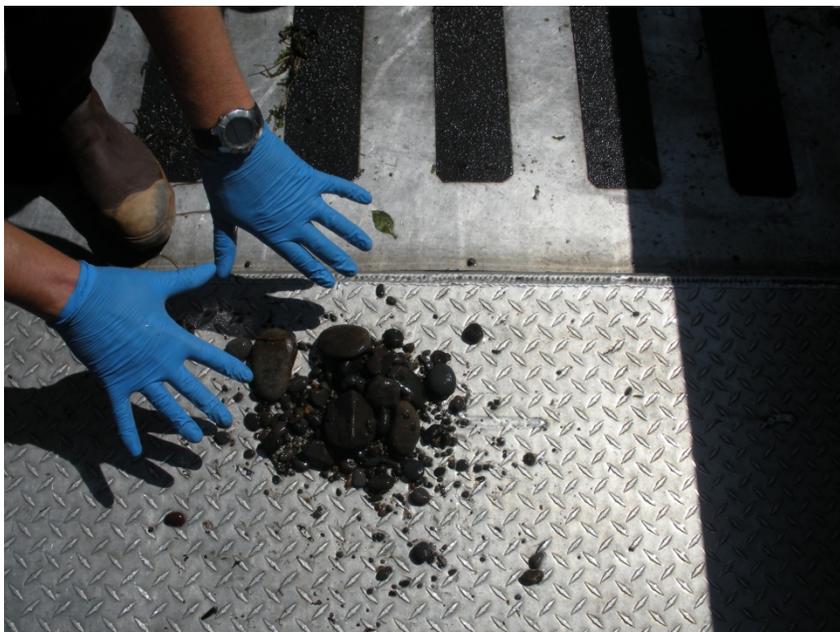
Photo: Material recovered on try 2.

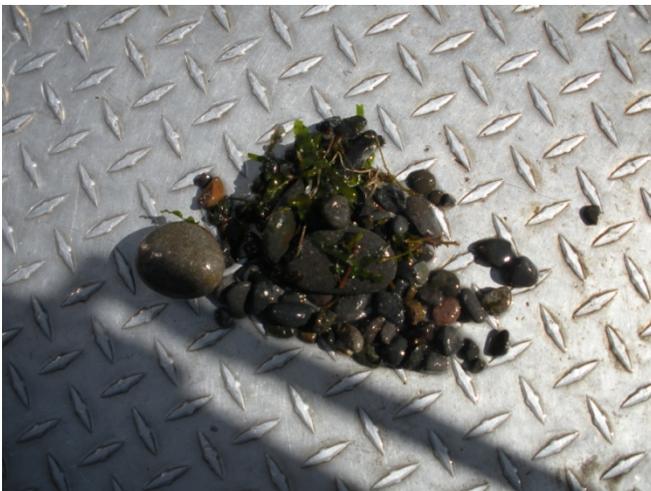
Photo: Material recovered on try 1.
