Gold Ray Dam Project

Rehabilitation Technical Memo

February 2010

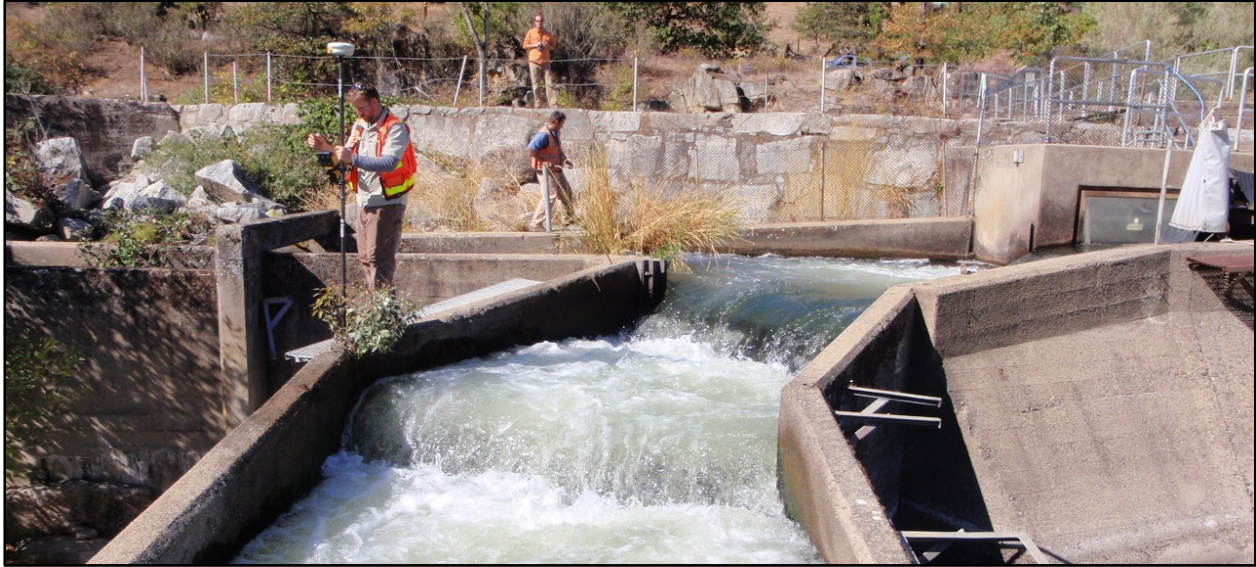
Figure 9: Surveying the Existing Fish Ladder with a Survey-grade GPS and Total Station

Surveys were completed using various methods. First, Watershed Sciences, Inc. collected Light Detection and Ranging (LiDAR) data for the project area in May 2009. Next, RDG completed detailed field data collection in September 2009 to characterize the existing site conditions at the dam, as well as conditions in the upstream reservoir area and in the river downstream from the dam. Data collection included topographic survey of the existing fish ladder, concrete dam, and surrounding structures. Water surface elevations were collected along with velocity profiles at the fish ladder for calibration of the hydraulic model. RDG data collection efforts utilized a total station (Topcon 211d) with data collector and a survey-grade GPS (Trimble R8) system to georeference the site. RDG also established horizontal and vertical control benchmarks for use throughout the project. Conditions in the upstream portion of the existing fish ladder are shown on Figure 9.

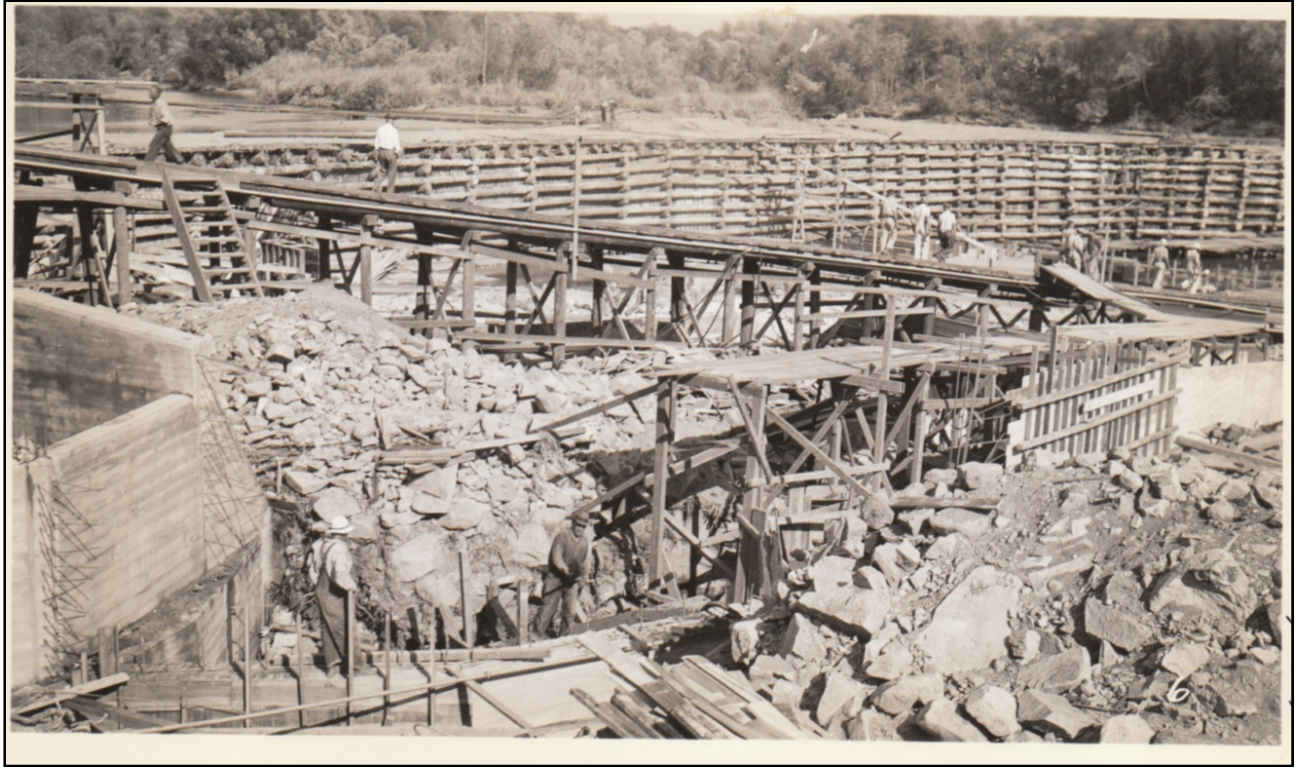
Figure 11: A View of Dam and Fish Ladder Construction in 1940
(photo courtesy of PacifiCorps historical records)

Fish passage has been provided at the Gold Ray Dam since the original log crib dam was installed and further upgraded in 1941 when the concrete fishway was built (Figure 11). This current fishway does not meet existing fish passage criteria and cannot be retrofit to provide passage. Therefore, to provide passage meeting current criteria, a new ladder would be required.
